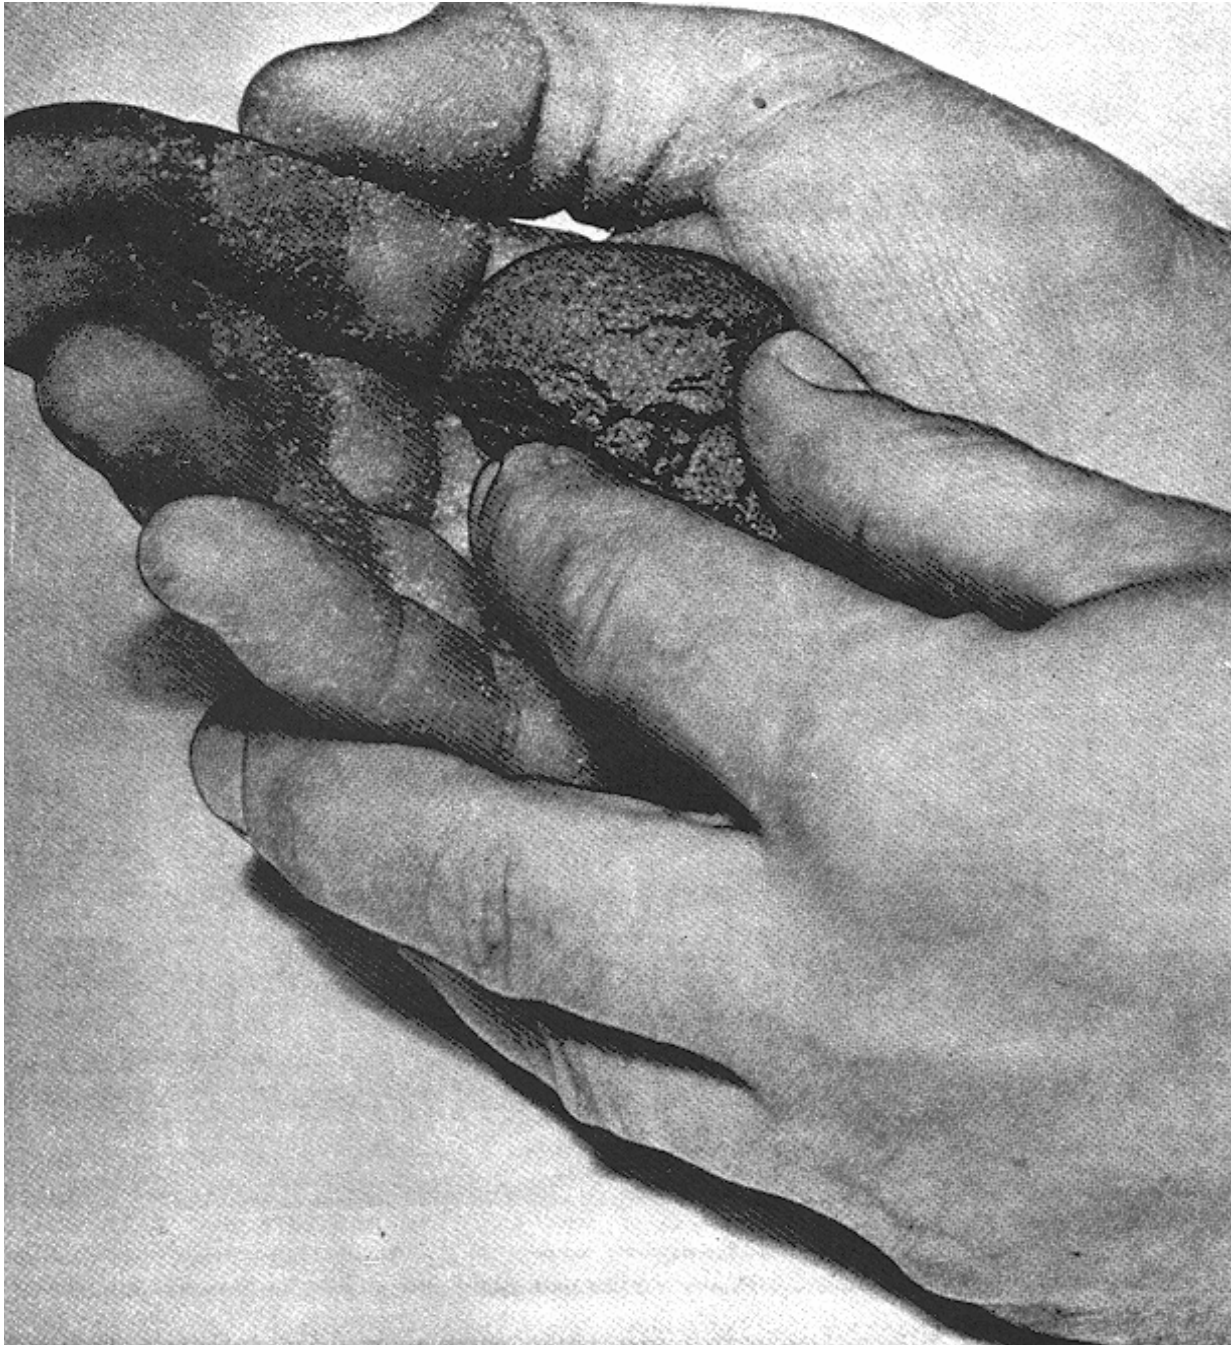
Figure E-7. A sample of a moist, fine-grained soil cracking and crumbling during the dilatancy test
